# MORROW COUNTY BOARD OF COMMISSIONERS MEETING AGENDA

Wednesday, December 15, 2021 at 9:00 a.m.

Assessment and Feasibility Study Overview	2
General Site Information	3
Morrow County Courthouse History and Historic Status	4
Morrow County Courthouse Existing Conditions Assessment	6
Executive Summary	6
Exterior Conditions	10
Interior Conditions	24
Mechanical Conditions	34
Electrical Conditions	36
Recommendations	40
JCF Criteria Analysis	44
Space Needs Analysis	48
Conceptual Layouts	51
Appendices	
Appendix A - Morrow County Space Need Summaries	
Appendix B - Morrow County Concept Layout Cost Estimates	
Appendix C - Morrow County Courthouse - ASCE 41-17 Tier 1 Seismic Eval.

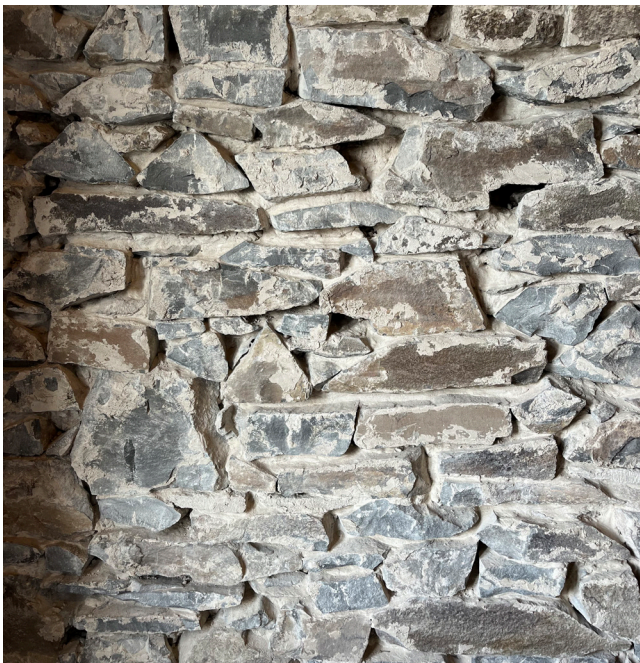
The Morrow County Courthouse is categorized as an unreinforced masonry (URM) bearing wall structure. This means that the exterior bearing walls are composed of solid masonry with no internal cavity and no reinforcing such as rebar. The walls of the courthouse are composed of rock face basalt stones held together by mortar that continue down below ground and form the foundation walls. The National Register Nomination notes the basalt was extracted from a quarry located just outside of Heppner. The building also features accents at the corners as well as the door and window surrounds that is noted in the original drawings as being sandstone from the La Grande area. The mortar joints are finished with a distinctive “beaded” profile on the exterior. The basalt and sandstone units themselves appear to be in very good condition with very few spalled surfaces noted. Mortar at the main volume of the building appeared to be mostly intact and well bonded. A few areas were observed where mortar was missing, mostly under the water table at the first floor. The mortar at the basement level (where accessible) and at the bell tower was noted to be extremely soft and powdery. The

*Stone wall at bell tower - mortar removal in process*

**Recommendations:** The soft mortar observed at the basement walls is of concern as the mortar is key to the strength of the wall assembly. The evaluation team recommends a more comprehensive evaluation of the stone walls at the basement be performed to determine the scope of mortar pointing required, but it is likely that all below grade stone walls require pointing. Likewise, the stone walls at the bell tower should be evaluated, but it is also likely that all of these walls require pointing as well. The south building wall mortar should also be repaired to remove the caulking material and replace with mortar. **These mortar conditions should be evaluated and addressed as soon as possible.**

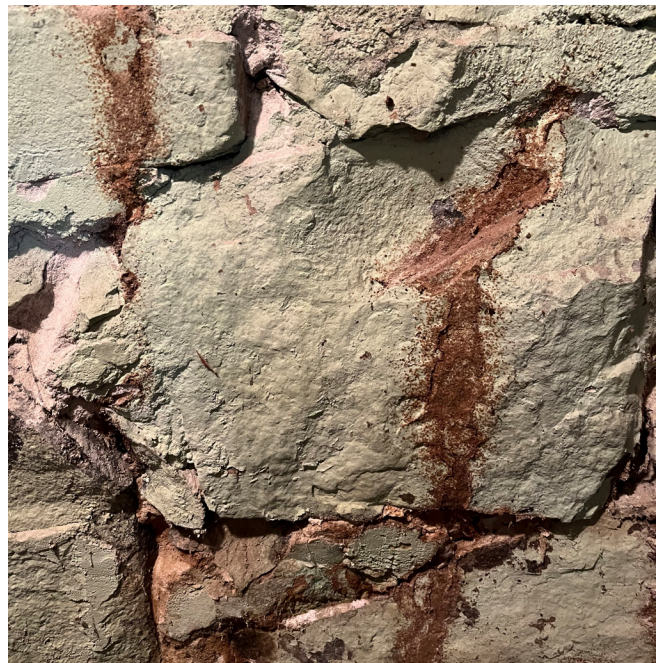
The Morrow County Courthouse is primarily a basalt stone bearing wall building on a mortared stone foundation. Foundation walls were only exposed to view in select areas of the basement and crawl spaces. The stones themselves are in very good condition with no signs of surface spalling observed. The areas of the foundation walls that were visible in the basement did not show any visible cracks or bulges, however, the mortar in these areas is quite soft and powdery. The above grade stone walls appeared to be in sound condition and the mortar observed in these areas appeared to be mostly adhered and sound. The stone walls at the bell tower exhibited the same soft mortar issue that was observed at the basement. The south wall of the building was previously caulked along the majority of the mortar joints. This is an improper repair method and it is failing. The roof areas are covered in a cedar shake shingle system. The shingles are showing signs of weathering including curling and cracking. There were also multiple areas observed within the attic where daylight was visible between shingles. The sheet metal dormer windows at the attic showed some signs of water damage on the inside. The cupola was replaced and clock/bell mechanisms were refurbished in 2014. The majority of the original windows have been replaced with modern wood sashes that have insulated glazing. The window paint appears to be in relatively good condition. An entry vestibule addition has been placed on the back side of the building that is not original or historic. There is currently no accessible pedestrian access between the courthouse and the Bartholomew Building.

*Interior face of stone wall at basement showing signs of staining and soft mortar*

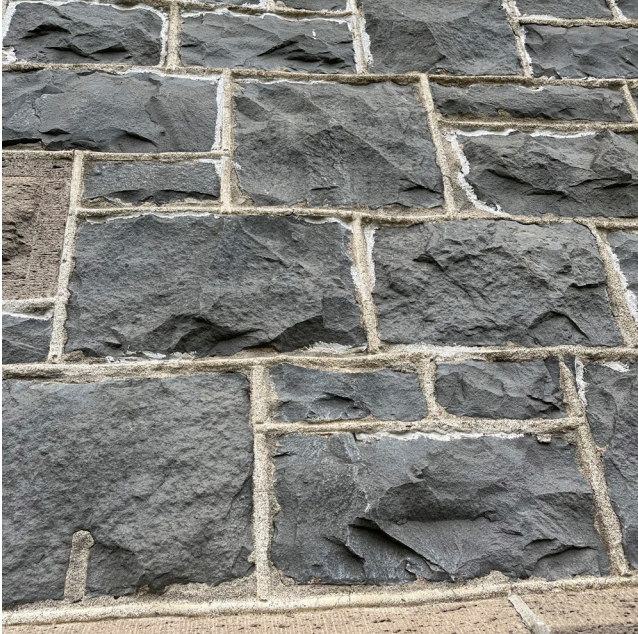
*White lines of caulk adjacent to mortar joints at south wall*

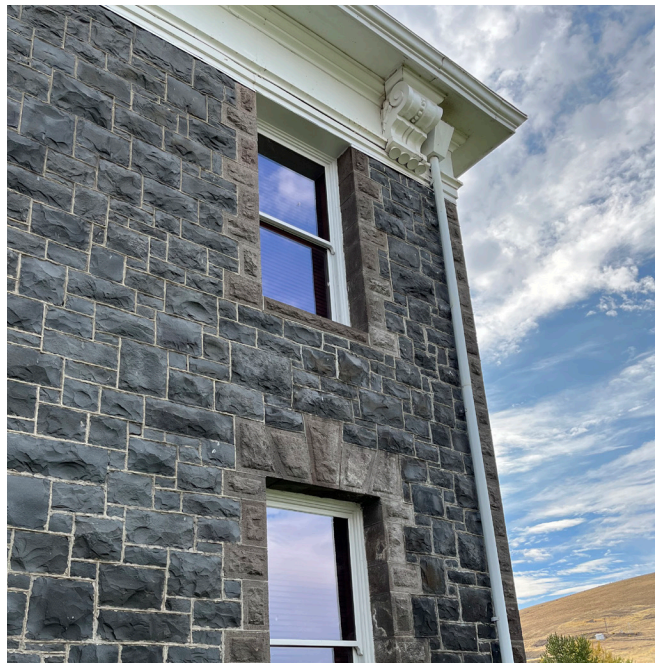
Building facilities noted that there was previously a vertical crack at the northwest corner of the building adjacent to a downspout. The crack was repaired within the last year or so and the repairs appear to be stable. No cracking was observed at the time of the site visit and no obvious displacement of the wall was noted. The area should be monitored regularly for signs of the crack re-forming.

*Northwest corner where crack was repaired*

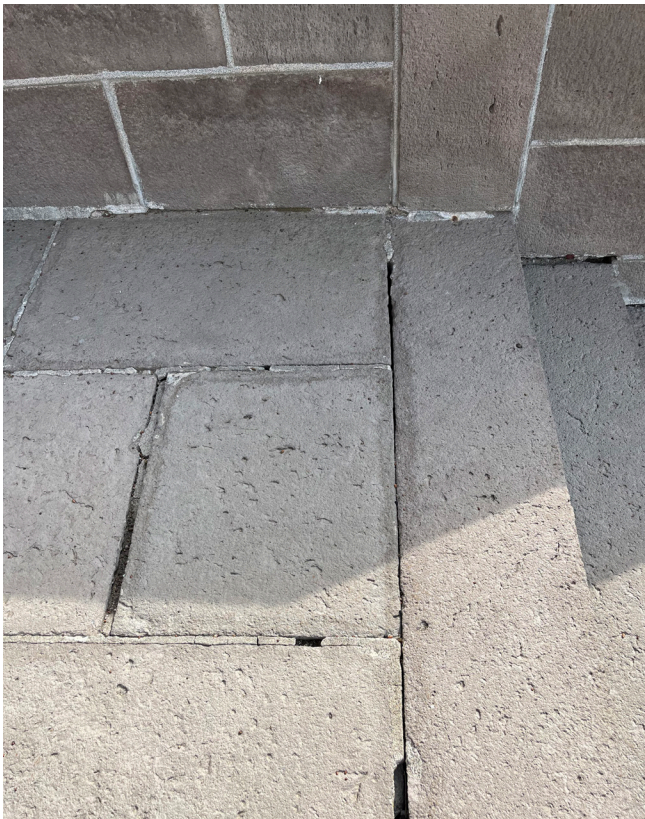
The site slopes dramatically to the west and a curved staircase leads from the sidewalk level up to the historic entry doors. The staircase is over 80' long and is formed of sandstone treads and landings lined with a basalt stone knee wall with a sandstone cap. The mortar joints at the landings are missing in multiple areas. The mortar joints at the knee wall are also failing in multiple areas. The mortar at the surface appears to be Portland cement based and is showing evidence of bonding issues. This may be due to a previous repair that changed mortar types and/or did not fully remove deteriorated mortar prior to pointing.

*Exterior stone stair landing with missing mortar joints*

Site: The stone staircase leading up to the building and the stone retaining wall that runs the western edge of the site show signs of mortar deterioration and are likely due for full pointing of those joints. An accessible (and possibly covered) pedestrian route between the courthouse and the Bartholomew Building should be explored as part of any future remodel of the courthouse.

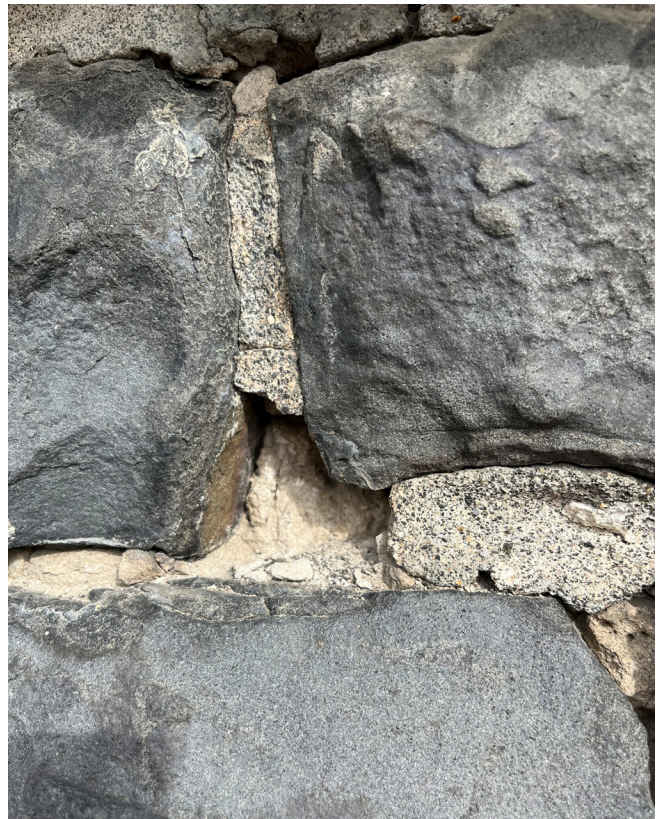
*Mortar at stone retaining wall showing bonding issues*

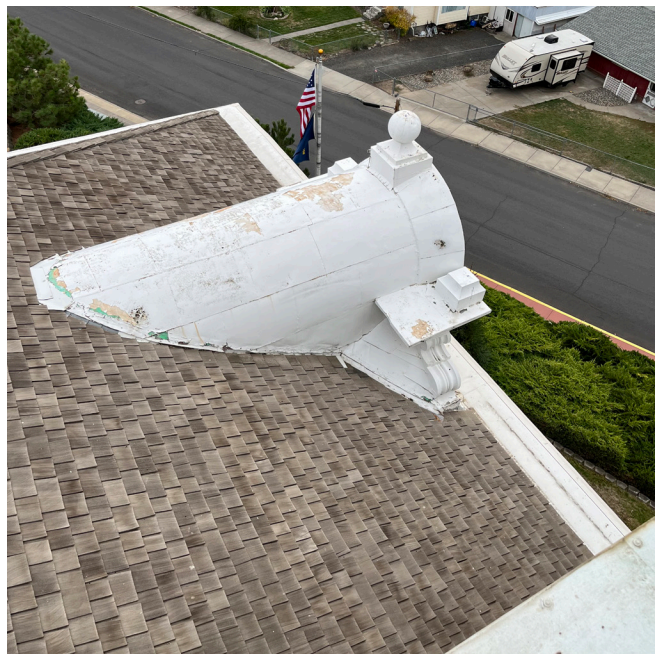
*Typical sheet metal dormer showing signs of paint peeling*

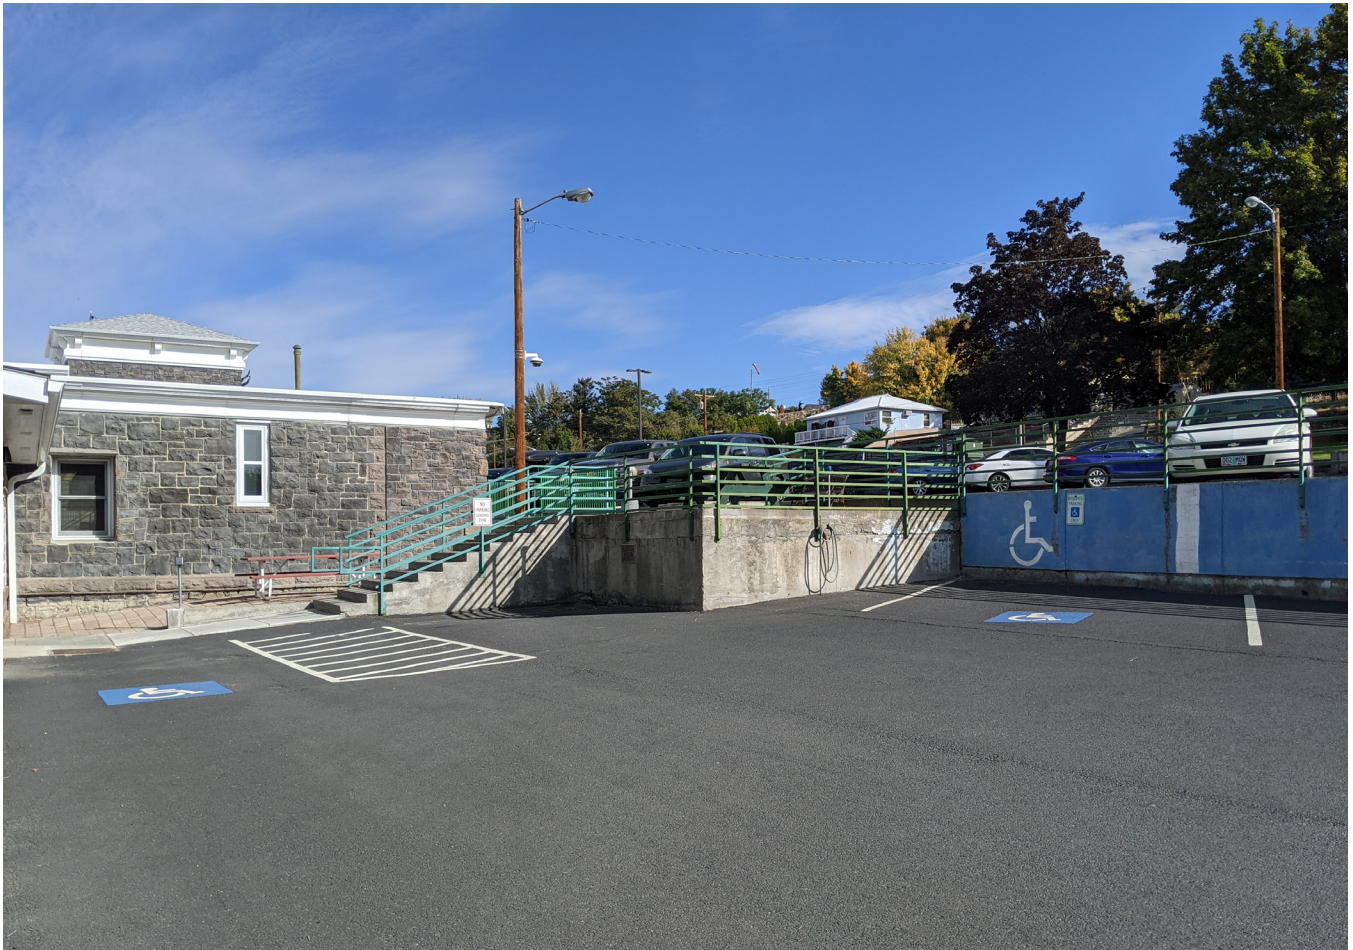
From a security standpoint, there are no architectural barriers separating the lower public parking area from the entrance to the courthouse.

*Stairs leading to the upper parking lot as well as the sidewalk to the Bartholomew Building*

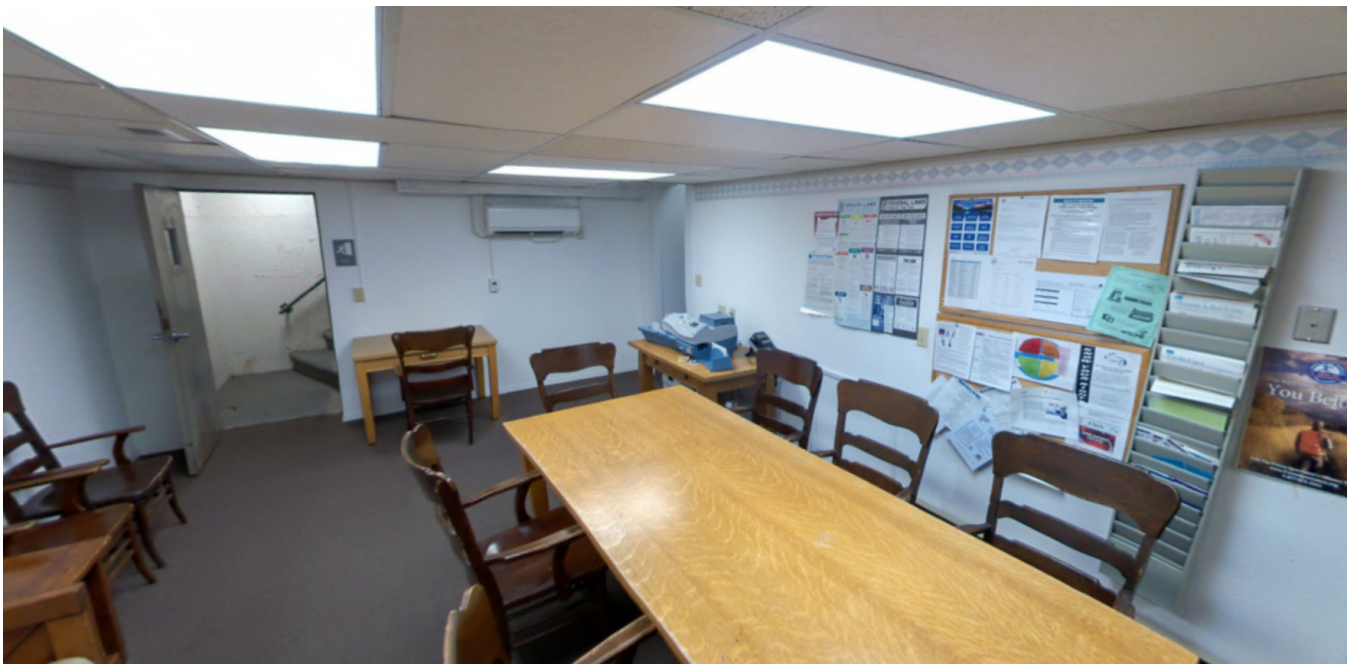
This level is accessed from the interior by two staircases. Both of these stairs are extremely steep and narrow and are challenging to navigate safely. There is also an exit directly to the exterior at the southwest corner adjacent to the elevator pit. The elevator does not serve the basement

*Basement break room looking east. Stairs to first floor at the back wall*

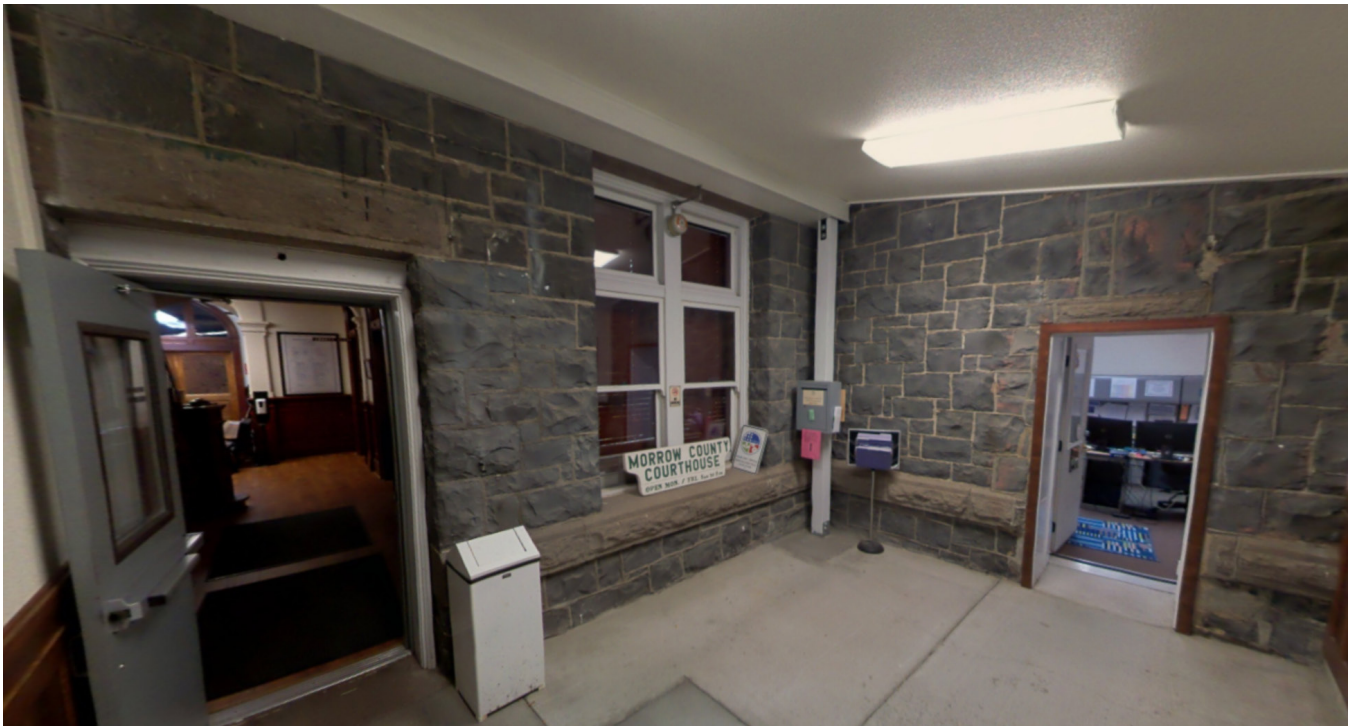
The entry vestibule provides a covered connection between the victim service office and the main courthouse building. The vestibule also covers a second stair to the basement. This stair is extremely steep and contains winder treads at the bottom. This enclosure is in poor condition with evidence of significant water damage at the concrete walls. Several steel plates with straps are supporting the ceiling above the bottom landing. The steel is heavily corroded.

*First floor entry vestibule area with door into courthouse on the left and access to Victim Services on the right.*

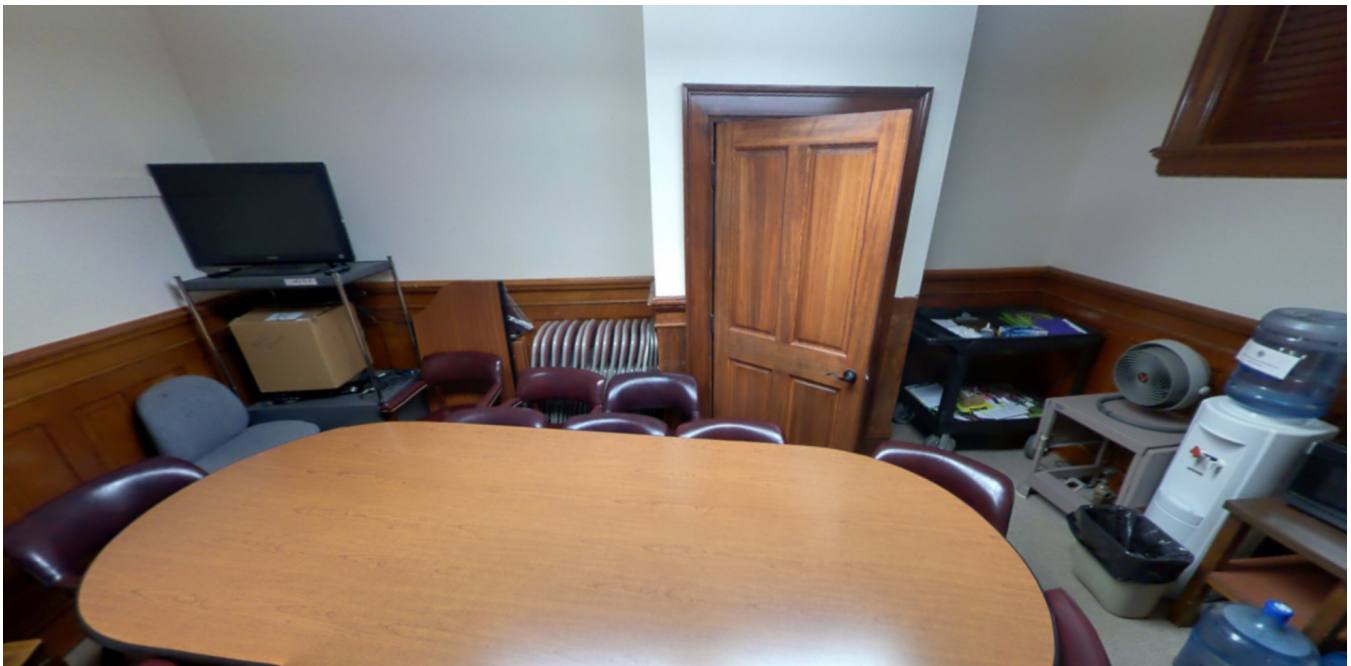
The jury deliberation room is located directly adjacent to the courtroom to the south of the judge's bench. The room is undersized for the necessary capacity. There is a conference table that seats 10 with additional chairs to the side. A closet has been added to the south wall of the room that protects the cabling that connects the clock mechanism in the lobby below to the clock tower above. A small space on the west wall is dedicated as a refreshment area. There is a single-user restroom within the deliberation room, but it is not ADA compliant. The jury deliberation room is not adequately separated acoustically from the courtroom or the judicial office to prevent sensitive conversations from being overheard.

*Jury deliberation room directly adjacent to the courtroom with closed for clock cabling.*
