# MORROW COUNTY BOARD OF COMMISSIONERS MEETING AGENDA

Wednesday, December 15, 2021 at 9:00 a.m.

Assessment and Feasibility Study Overview	2
General Site Information	3
Morrow County Courthouse History and Historic Status	4
Morrow County Courthouse Existing Conditions Assessment	6
Executive Summary	6
Exterior Conditions	10
Interior Conditions	24
Mechanical Conditions	34
Electrical Conditions	36
Recommendations	40
JCF Criteria Analysis	44
Space Needs Analysis	48
Conceptual Layouts	51
Appendices	
Appendix A - Morrow County Space Need Summaries	
Appendix B - Morrow County Concept Layout Cost Estimates	
Appendix C - Morrow County Courthouse - ASCE 41-17 Tier 1 Seismic Eval.

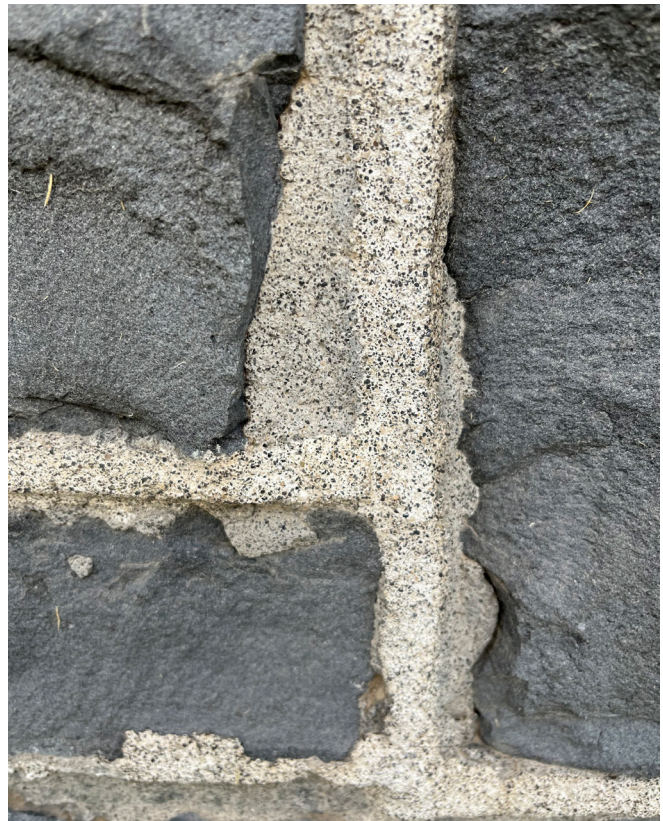
The Morrow County Courthouse is categorized as an unreinforced masonry (URM) bearing wall structure. This means that the exterior bearing walls are composed of solid masonry with no internal cavity and no reinforcing such as rebar. The walls of the courthouse are composed of rock face basalt stones held together by mortar that continue down below ground and form the foundation walls. The National Register Nomination notes the basalt was extracted from a quarry located just outside of Heppner. The building also features accents at the corners as well as the door and window surrounds that is noted in the original drawings as being sandstone from the La Grande area. The mortar joints are finished with a distinctive “beaded” profile on the exterior. The basalt and sandstone units themselves appear to be in very good condition with very few spalled surfaces noted. Mortar at the main volume of the building appeared to be mostly intact and well bonded. A few areas were observed where mortar was missing, mostly under the water table at the first floor. The mortar at the basement level (where accessible) and at the bell tower was noted to be extremely soft and powdery. The

*Beaded mortar joint profile*

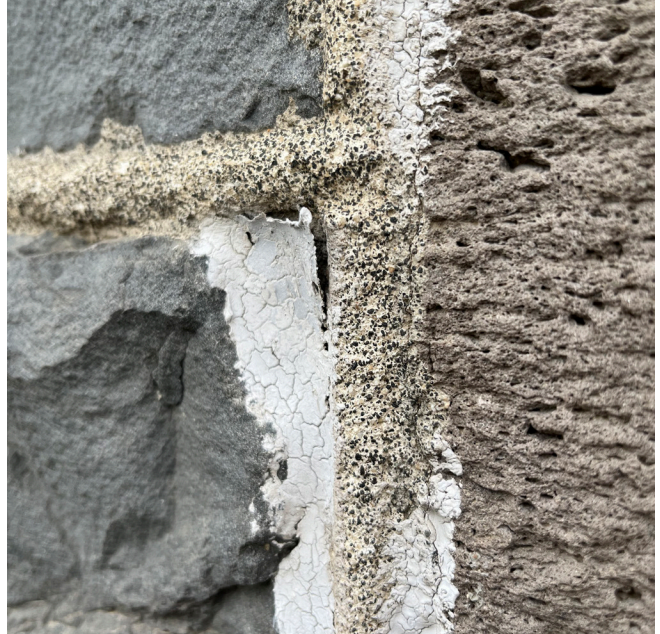
The mortar joints on the south wall of the building appear to have had a poly-urethane caulk applied adjacent to the mortar joints. It is likely that this was an attempt to fill gaps or address water infiltration issues, but it is not a recommended repair method as sealant can trap moisture inside of the wall and potentially exacerbate water issues. The caulk is not well adhered to the stone or mortar surfaces and can be easily pulled back.

*Close-up view of caulking*

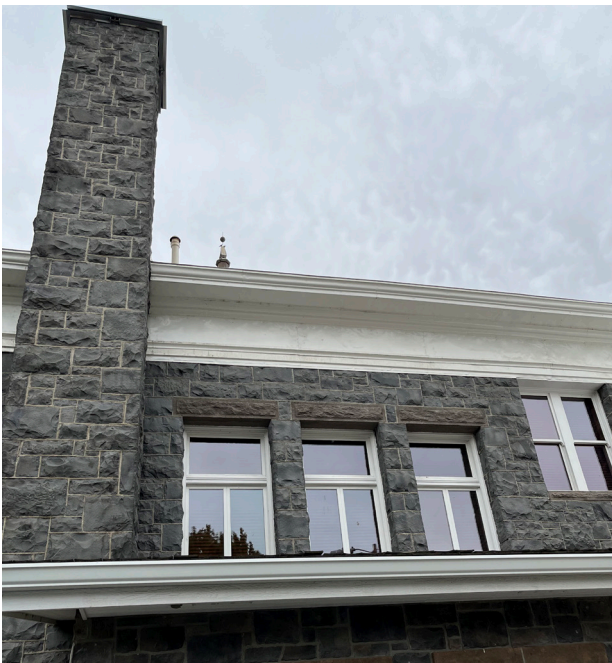
*Chimney at east wall*

The existing un-reinforced stone chimney on the east facade should be removed, reinforced or at a minimum taken down to the roof line as it poses a significant safety risk in a seismic event. The existing cedar shake roofs should be evaluated by a qualified roofing contractor to determine whether repair is feasible or if full replacement is required. The sheet metal dormers should be further evaluated to determine if sheet metal joints are properly sealed. The two stone statues above the historic main entry should be seismically restrained to ensure that they do not detach in a seismic event.

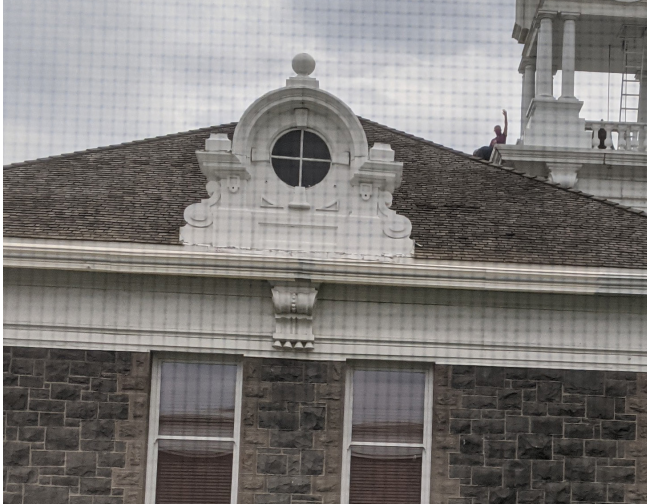
*Typical sheet metal dormer*

There are four barrel shaped dormers located on sloped roof areas: two on the west side, one on the north and one on the south. These dormers are painted, formed sheet metal and contain a circular window in each one. The dormers exhibited peeling paint at the exterior and signs of water staining at the wood support framing at the interior.

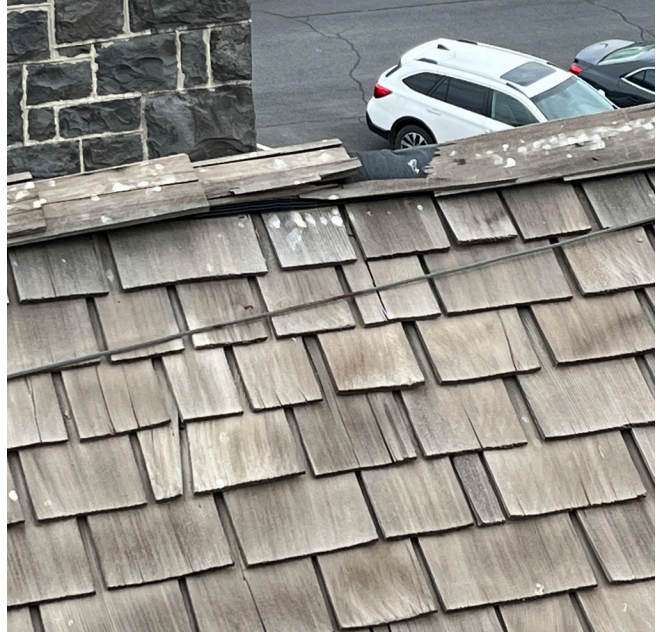
*Shingles showing signs of weathering*

The main building volume is capped with a hip roof clad in cedar shake shingles. The shingles are applied over an underlayment material and nailed to wood skip sheathing. The shingles observed showed signs of weathering including cracking, splitting and curling. There were also multiple areas in the attic where daylight could be seen in gaps between the shingles. Cedar shake shingles do expand and contract depending on moisture levels and temperature, and some level of curling is expected. The weathering observed did appear to be more advanced with many areas splitting and missing ridge units.

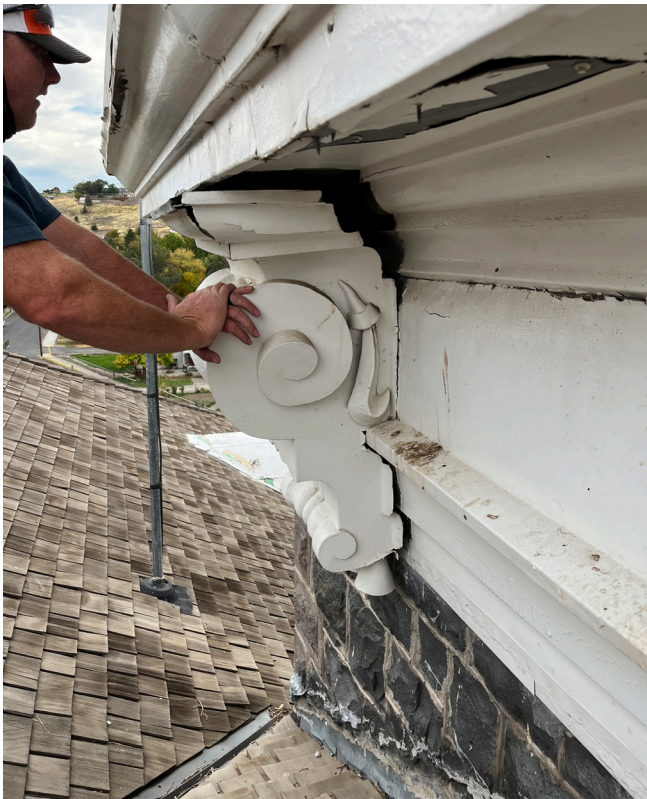
*Separating bracket under clock tower*

The main sloped roof areas drain to an exterior gutter system with exposed downspouts located throughout the exterior. These gutters are integrated into a wood and sheet metal cornice that occurs at the perimeter of both the main roof and at the base of the clock tower. There are also ornamental sheet metal brackets that occur at both of these cornice lines. The team observed two locations along the east side of the bell tower cornice where these brackets were separating from the cornice. These brackets are located at the back side of the bell tower just above the main roof.

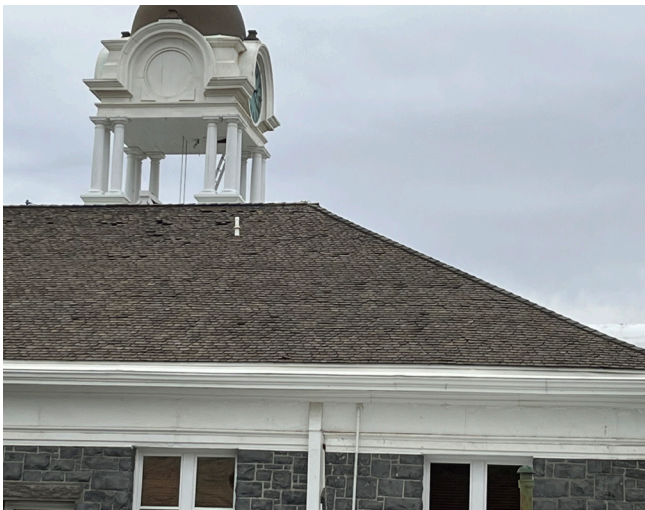
*Cedar shake shingle roof*

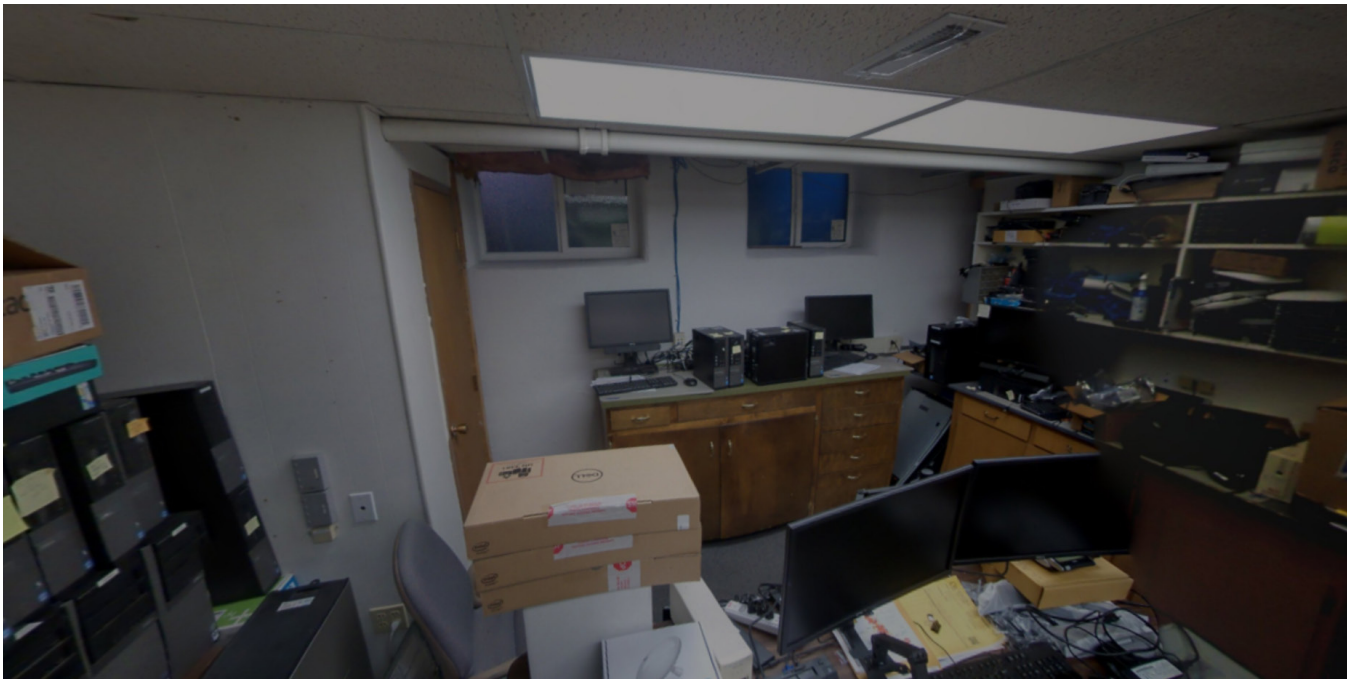
There is an original historic vault being utilized as records storage. There is no humidity control or ventilation air in the basement and the storage vault had a strong smell that suggests the potential presence of mildew. An air quality report provided by the county noted that moisture has been an issue in the basement previously. While no current areas of water damage were noted, the plaster at the west wall was recently repaired and the windows replaced with new vinyl sliders.

*West basement wall was recently re-plastered and windows were replaced.*

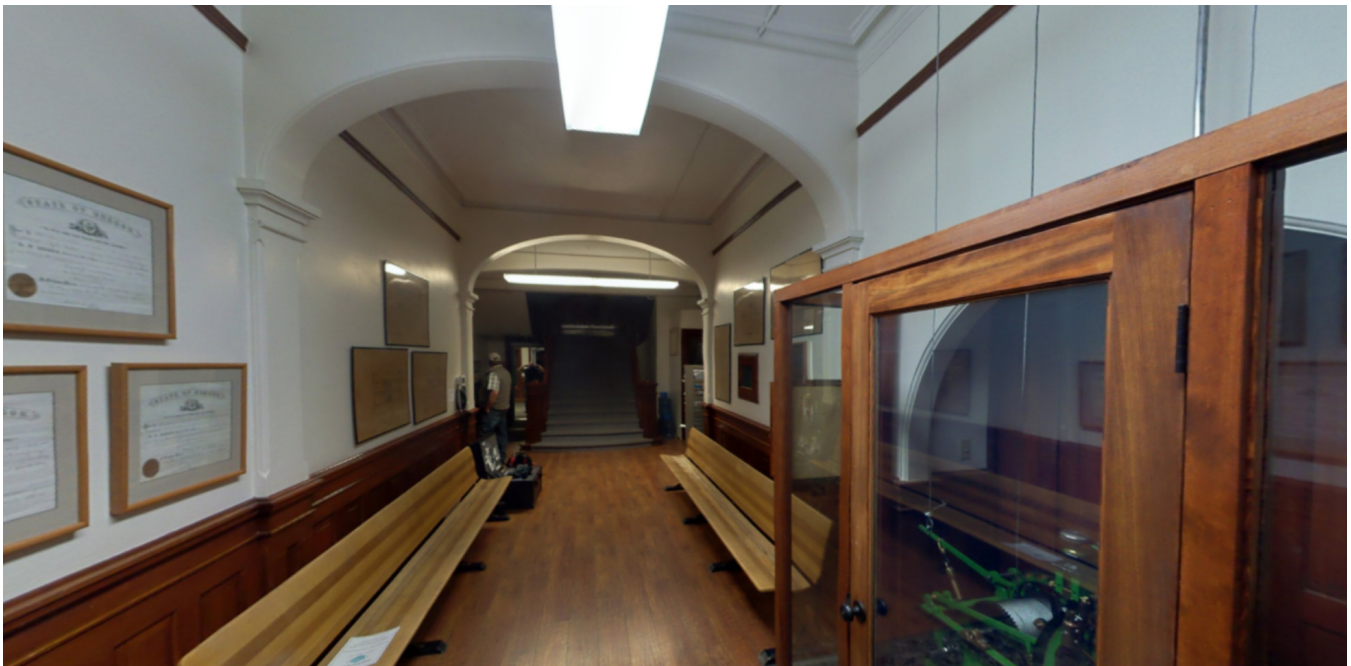
Almost all of the areas still have the original historic wood doors, relites and transoms as well as original running trim and wainscot. The wood surfaces are in good condition, but are due for finish touch-up and refinishing in higher traffic areas.

*First floor historic foyer with historic clock mechanism display to the right*

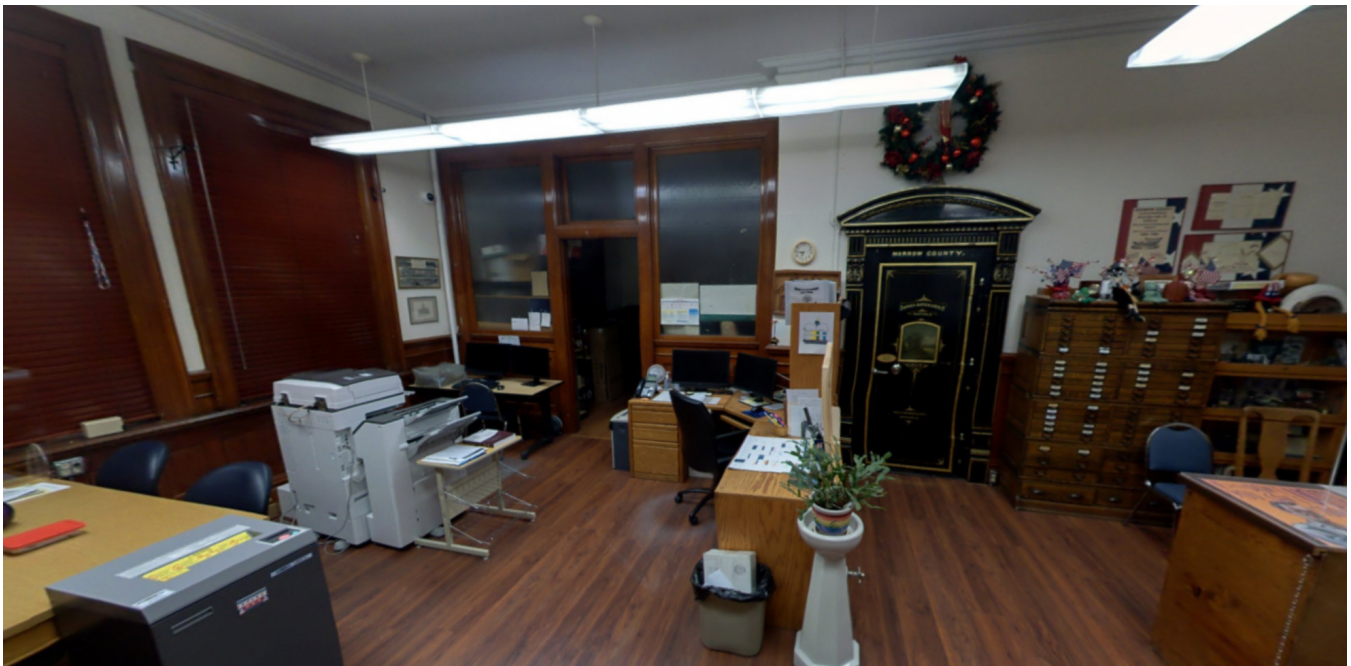
*First floor Morrow County Clerk's office with original storage vault in the background.*

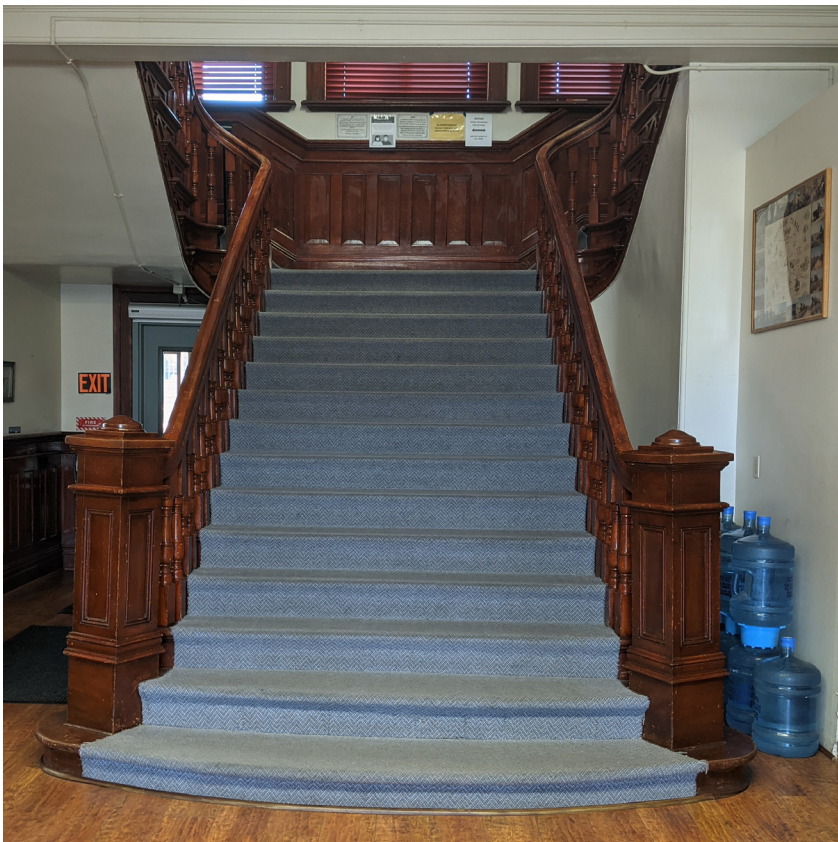
A central 'grand staircase' sits on axis with the historic building entrance on the first floor and then splits to each side at an intermediate landing before ultimately landing at the historic courtroom lobby. The stair features the original wood balustrade, newel posts and wood wainscot on the wall side. The woodwork is overall in very good condition, but is likely due for general refinishing to address general wear and tear such as surface scratches and areas where the stained finish has worn off. The historic balustrade does not meet current code requirements for guardrail height and the stair does not have separate handrails. Modifications to the balustrade railing can be done, but they are difficult and often have a negative impact on the historic character. There is an opportunity to add handrails at the wall sides of the stair which could improve safety with minimal visual impact. In a renovation scenario, the building official may at their discretion require modifications to the stair rail to better meet life/safety requirements.

*Grand staircase at the first floor leading up to the Courtroom*

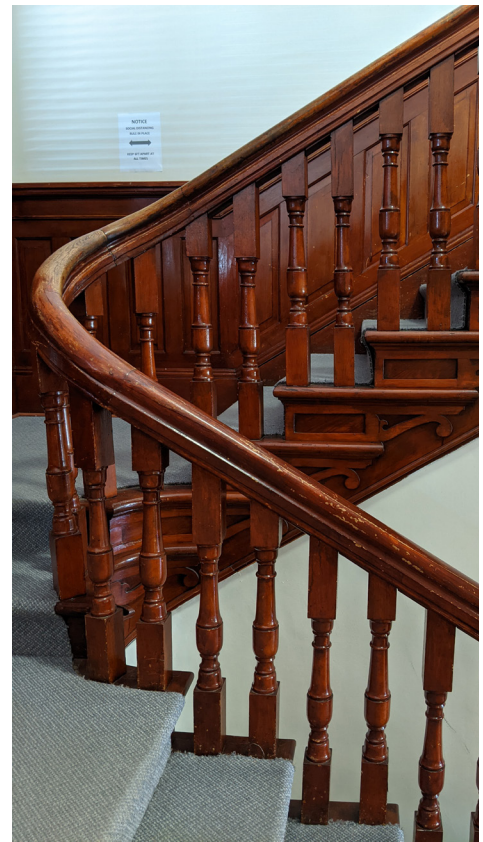
*Detail view of historic wood balustrade*

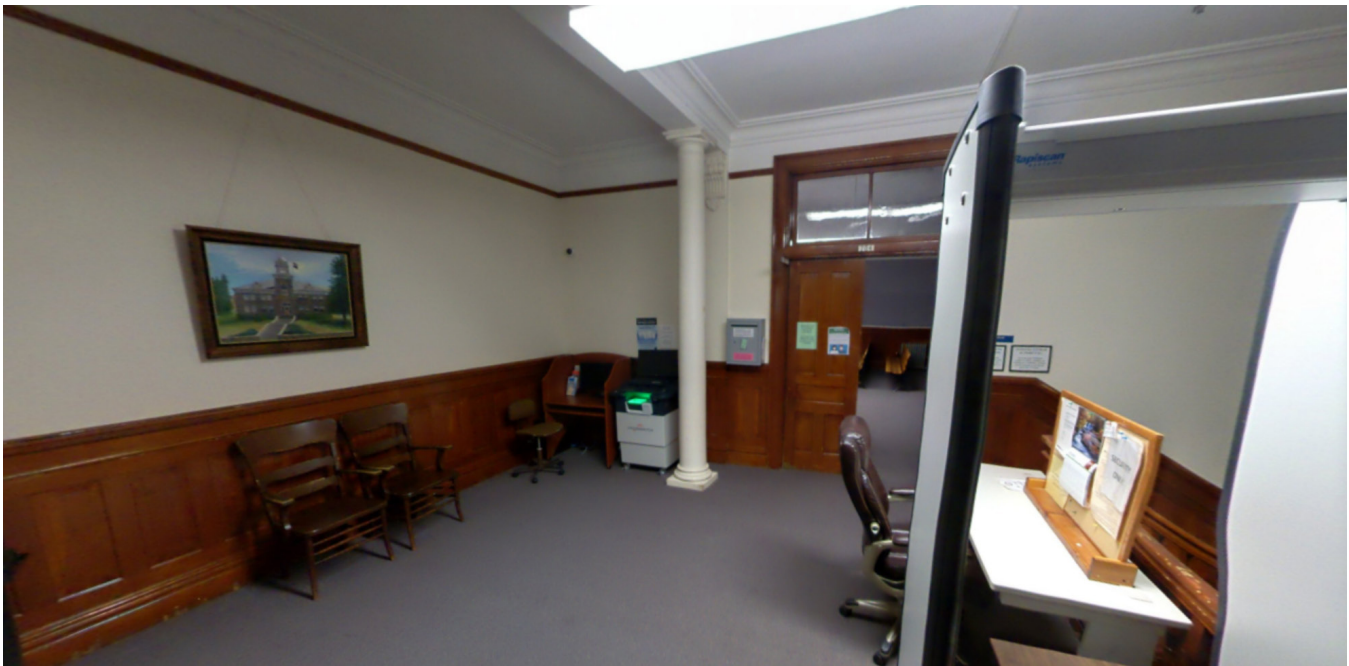
*Second floor courtroom lobby with security screening station*

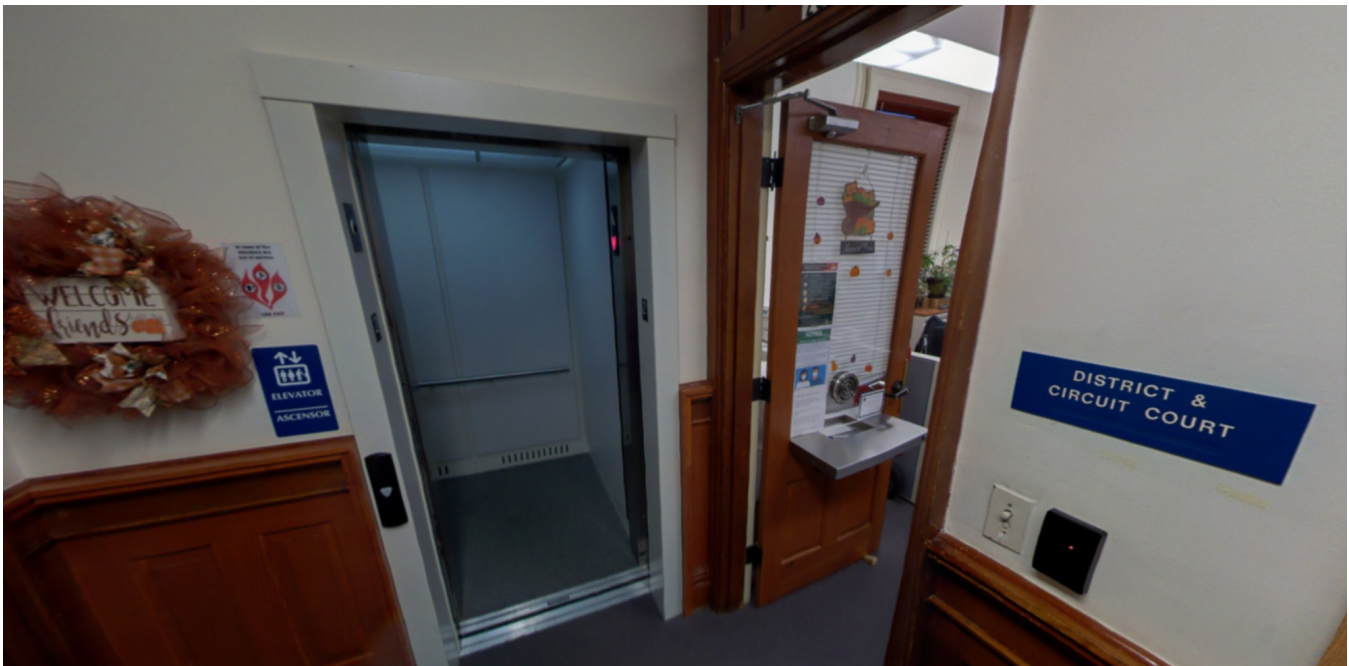
There is a very small kitchenette area located in the entryway to a single-user restroom that is accessible to staff and the public. The judicial offices and jury deliberation rooms also have single-user restrooms within their spaces. None of these restrooms meet current ADA standards for accessibility.

*Second floor public hallway with elevator and public transaction area at door of circuit court administrative area*

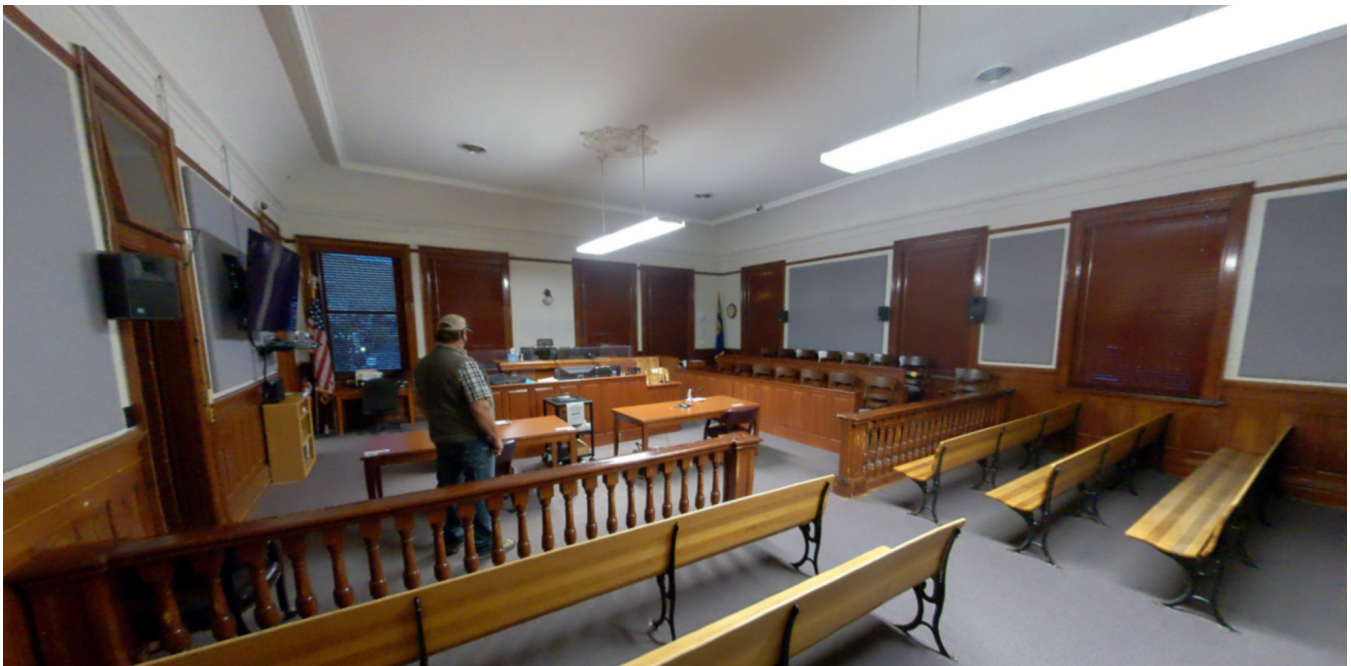
*View of historic courtroom featuring original furnishings*

ceiling maintain the original plaster finish and plasterwork medallions. There were several locations of water damaged plaster on the courtroom ceiling. This appears to be the result of water leaking from one of the HVAC units located in the attic. Fabric wrapped acoustic panels have been added to the courtroom walls. This type of panel is not intended to provide acoustic separation, but rather to reduce reverberation within the space.

- Repair historic finishes at areas of past water damage and address normal wear and tear.
